Manhole Inspection Summary

Manhole # S53AA_006MH

Insp Date: **7/17/08 8:34 AM**

Location Address: **527 n east av**

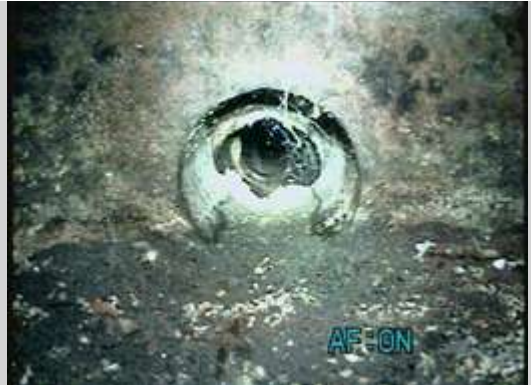
12 O'Clock Outflow

8 in. Circular Gravity Sewer
Pipe Out @ 12 O'Clock

Infiltration: **None** Pipe Seal Cond: **Unknown**
